DEPARTMENT OF TRANSPORTATION**DIVISION OF ENGINEERING SERVICES**

Contract #: 04-0120F4Cty: SF/ALA Rte: 80 PM: 13.2/13.9File #: 69.28**WELDING INSPECTION REPORT****Resident Engineer:**Siegenthaler, Peter**Address:** 333 Burma Road**City:** Oakland, CA 94607**Report No:** WIR-022516**Date Inspected:** 12-Apr-2011**Project Name:** SAS Superstructure**OSM Arrival Time:** 700**Prime Contractor:** American Bridge/Fluor Enterprises, a JV**OSM Departure Time:** 1900**Contractor:** Zhenhua Port Machinery Company, Ltd (ZPMC), Changxing Island **Location:** Shanghai, China**CWI Name:** Mr. Liu hua jie**CWI Present:** Yes No**Inspected CWI report:** Yes No N/A**Rod Oven in Use:** Yes No N/A**Electrode to specification:** Yes No N/A**Weld Procedures Followed:** Yes No N/A**Qualified Welders:** Yes No N/A**Verified Joint Fit-up:** Yes No N/A**Approved Drawings:** Yes No N/A**Approved WPS:** Yes No N/A**Delayed / Cancelled:** Yes No N/A**Bridge No:** 34-0006**Component:** Orthotropic Box Girder(OBG)**Summary of Items Observed:**

OBG Trial Assembly open yard.

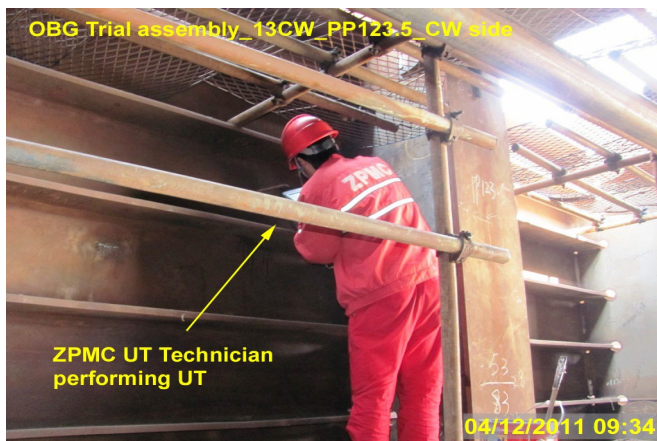
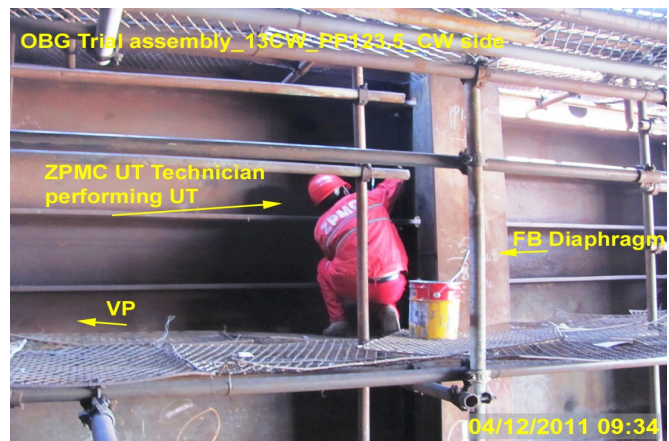
ZPMC UT Technician performing UT for the welds connecting to Vertical plate to Floor beam diaphragm at Panel point 123.5 Counter weight side. See attached photos for further information.
